# **FLOODING ON THE LOWER RIVER INCH, WEXFORD**

Paul Johnston,  
December 2019

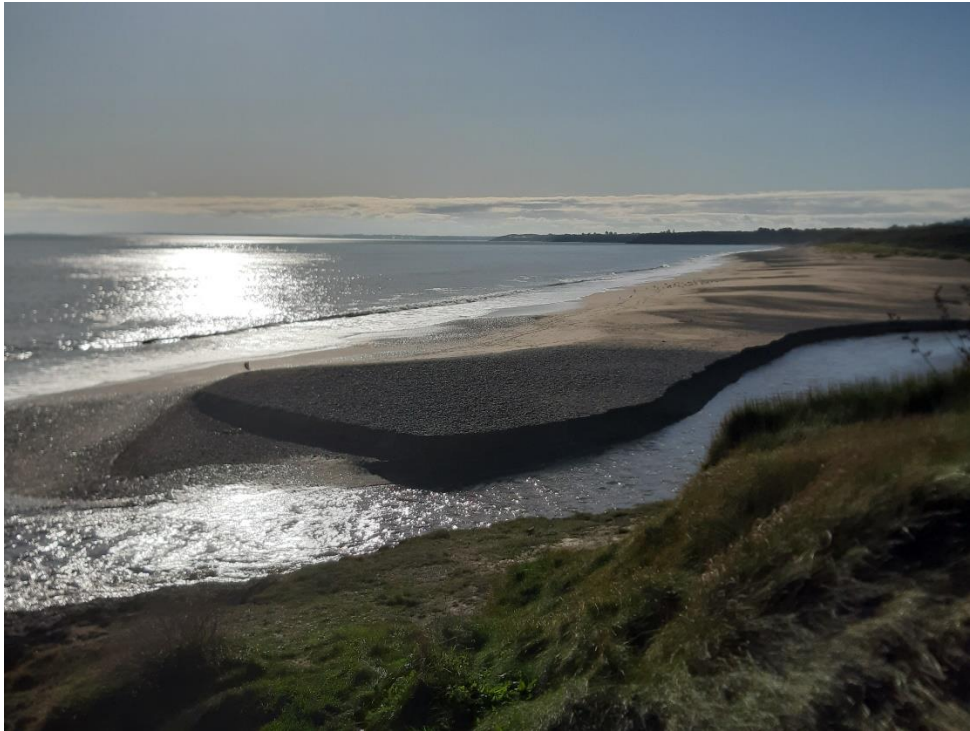
The river's course is strongly affected by the presence of a large sand bar at its mouth, diverting it northwards until it is forced, by the shape of the coast, to break through and discharge to the sea. This is a common pattern for a number of rivers on this part of the east coast, as the sediment forming the sand bar/spit is moving northwards under the prevailing southwest winds, causing longshore drift. While it is almost certainly a naturally formed landscape/shorescape, local residents reported that, for years, a channel had been created across the sand bar allowing the river direct access to the sea. It was suggested that this might reduce flooding risk upstream but also assist in facilitating access to the river for migratory fish.

Fig. 1 Sand bar or spit at the mouth of the Inch River, looking south

At the meeting, it was agreed that a channel across the sand bar could be re-instated on a trial basis but it would need maintenance and would only be of value if appropriate monitoring (before and after construction) were undertaken in order to establish its benefits.

It was noted that the quality of the river water is erratic, and less than ‘good’ at times, a characteristic which may have caused a significant impact on fish stocks. The sand bar and the pattern of discharge at the river mouth is a natural result of coastal processes. Notwithstanding this pattern, if a channel is to be cut through the sand bar on a trial basis, monitoring should be undertaken to determine its effect on flooding risk and on fish migration – in order to establish its ongoing benefit.

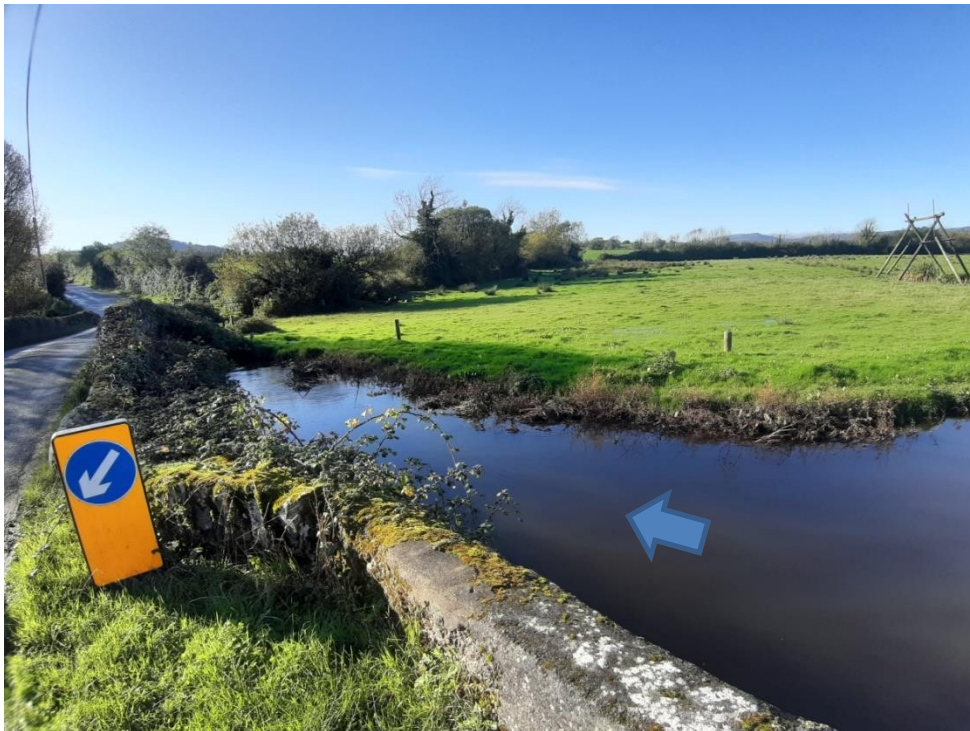
Fig. 2 Inch River at Ahare Bridge in summer conditions, looking south; flow from right to left

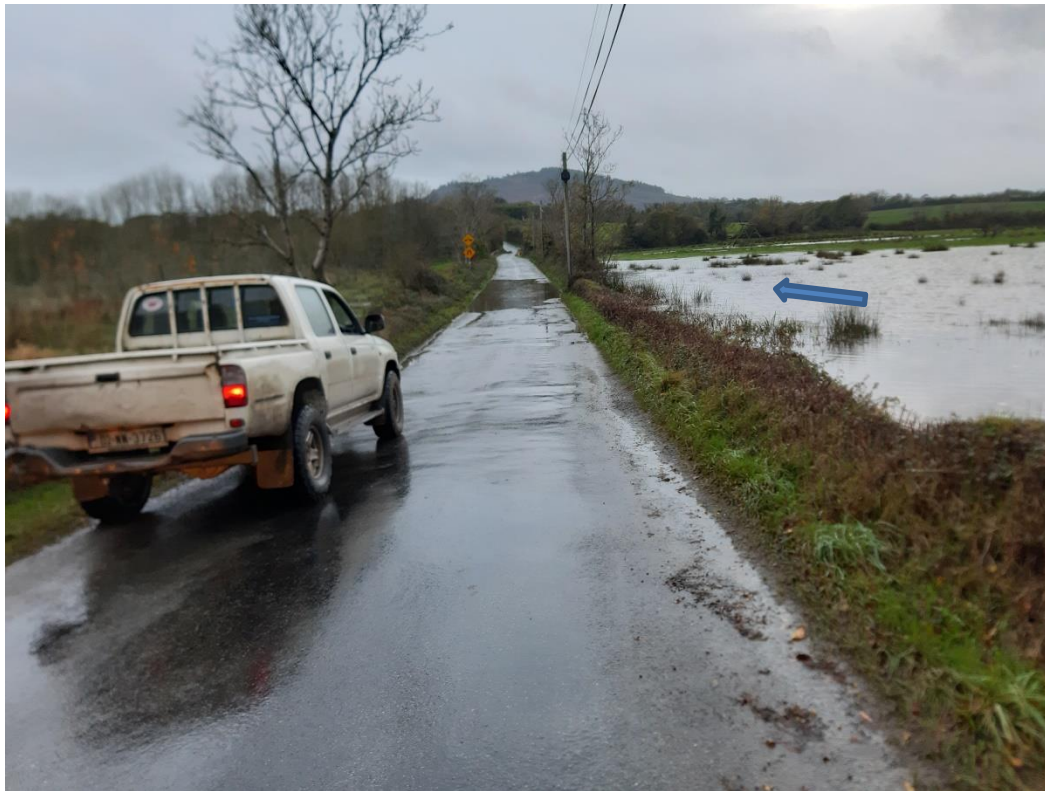
There is considerable concern at the reported increase in the frequency of flooding conditions at the bridge where the embankment and road comes under water, causing dangerous driving conditions. While the frequency of flooding may in part have been affected by an increase in storm rainfall under the influence of climate change, the presence of the low embankment suggests that flooding of the road was not a frequent occurrence historically. In short, the design of the road would have been expected to accommodate occasional flood events on the river as it is known to cross the entire width of the flood plain at that location. However, under current conditions, it appears that the embankment/road is acting as a partial *barrier* to the river flow draining towards the sea. Figure 3 shows the damming effect on the upstream side of the embankment.

Normally, a flood plain is a natural attenuation device for flooding as it acts as storage and causes a reduction in flow velocity. That might also have been the case here but for the current barrier effect of the road. However, it was reported by local residents that there are up to 7 culverts under the embankment but most are silted up or blocked. These would have served to allow most flood waters to pass readily under the road. Thus, it is suggested that opening these and restoring their function in order to fully utilize the flood plain downstream would go a long way to reducing the flooding risk at the road. Moreover, it would help to restore the floodplain as a natural wetland, as a refuge for wildlife with characteristic vegetation and, indeed, as an amenity. Such re-establishment of a floodplain for flood control is increasingly seen internationally as a sustainable 'natural solution' for mitigating flood risk and it is clearly of benefit here, provided it is carefully managed. Raising the road would be an ad hoc solution but would not mitigate the flooding of land upstream of Ahare Bridge.

Fig.3 Inch River at Ahare Bridge in flooding conditions; road acting as a dam; looking south

There is clearly a natural flood plain on the lower reaches of the River Inch. As an initial (partial?) solution to flooding of the road at Ahare Bridge, the function of the flood plain should be restored by re-opening existing culverts, thereby lowering flood levels and, indeed, re-creating an amenity wetland along the banks of the lower reaches of the river (as the existing vegetation already indicates has existed).

A monitoring station for water level should be established to indicate how the river responds to rainfall and to indicate how effective any changes might be, and to show how beneficial other construction (such as raising the road) might be. OPW or the EPA might be willing to establish such a station as the river at the moment is ungauged.

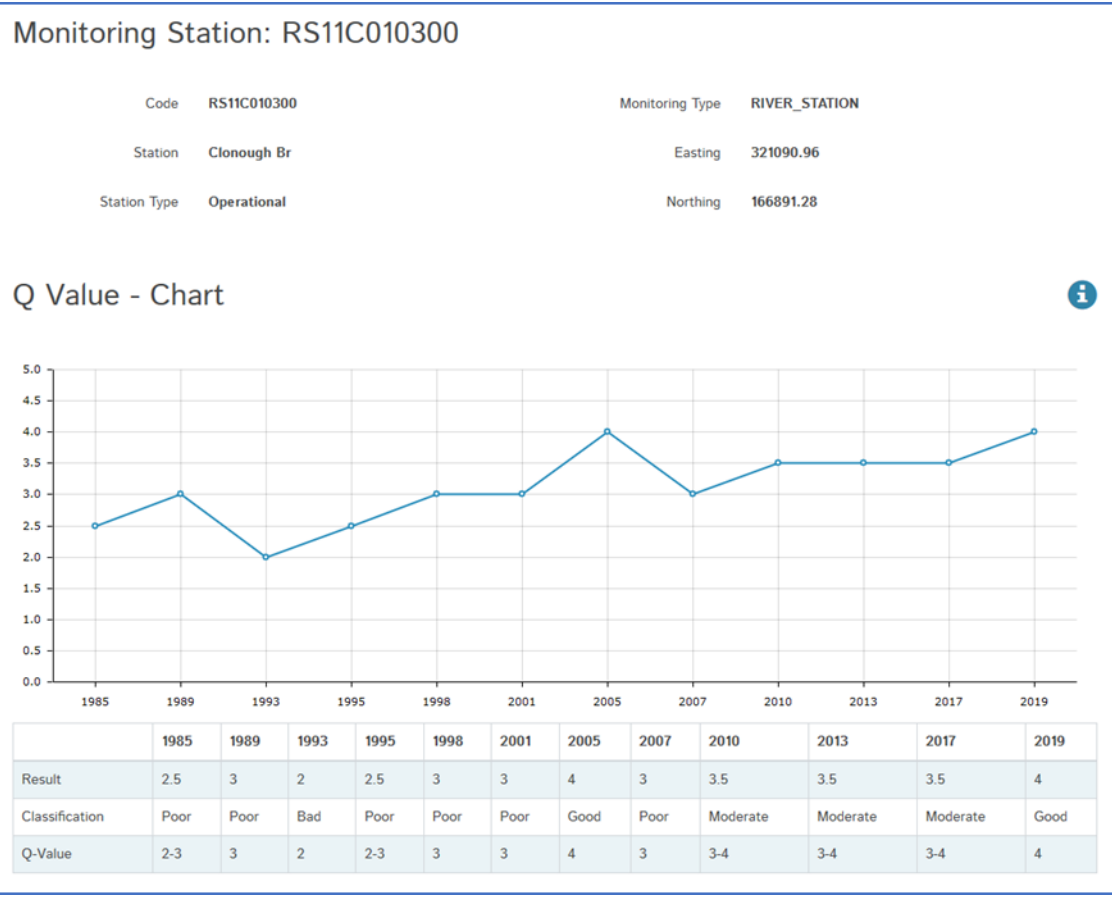
Fig. 6: **Water quality at Clonough Bridge**, upper Inch (Data : Ruth Hennessy, EPA)

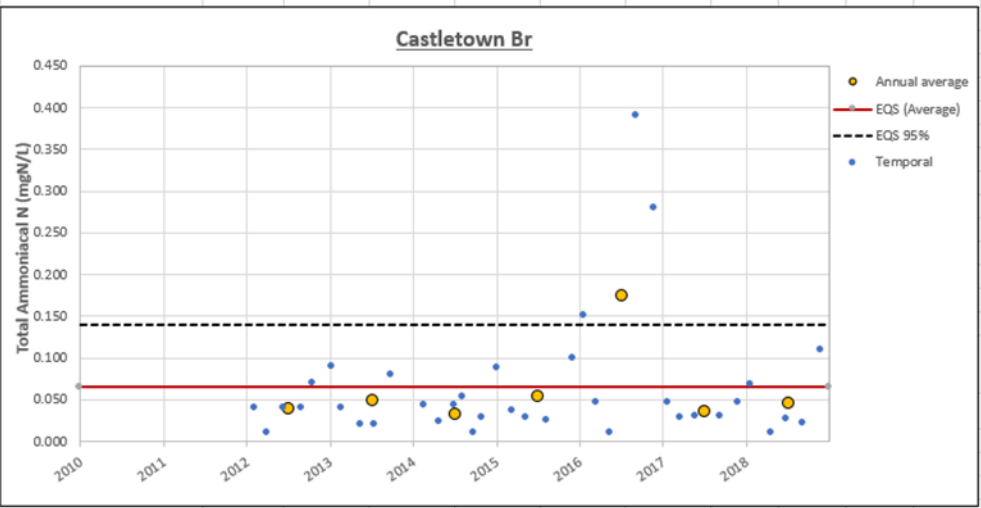
Conditions have deteriorated in recent years with a failure to maintain the channel along with a significant reduction in fish populations. Although under historical, natural flow conditions in the river, it is doubtful that fish numbers would have been affected, a significant factor in recent years has been the deterioration in water quality (eg ammonia, fig.7) as measured by the EPA upstream, probably related to agricultural practice. The effect of a channel through the spit on flooding levels upstream is likely to be small but a proper monitoring of flows, as suggested above, would be needed in order to resolve these issues.

Fig. 7 : **Ammonia at Castletown Bridge**: high values have been recorded, but not consistently (Data : Ruth Hennessy, EPA)
