## Introduction

This report captures a full year citizen science survey of the Ahare River and Estuary. The survey was undertaken by Cathy Lee, Castletown, Co. Wexford with support and advice from Karen Dubsky from Coast Watch Ireland and the Local Authorities Waters Programme (LAWPRO).

The survey was undertaken from September 2019 to September 2020 and focused on the biodiversity, water quality and river levels at two locations in the lower section of the Ahare /Inch River Catchment; namely Ahare Bridge (52°43'00.4"N 6°11'15.8"W) and the mouth of the Ahare River on Clone Beach, north County Wexford.

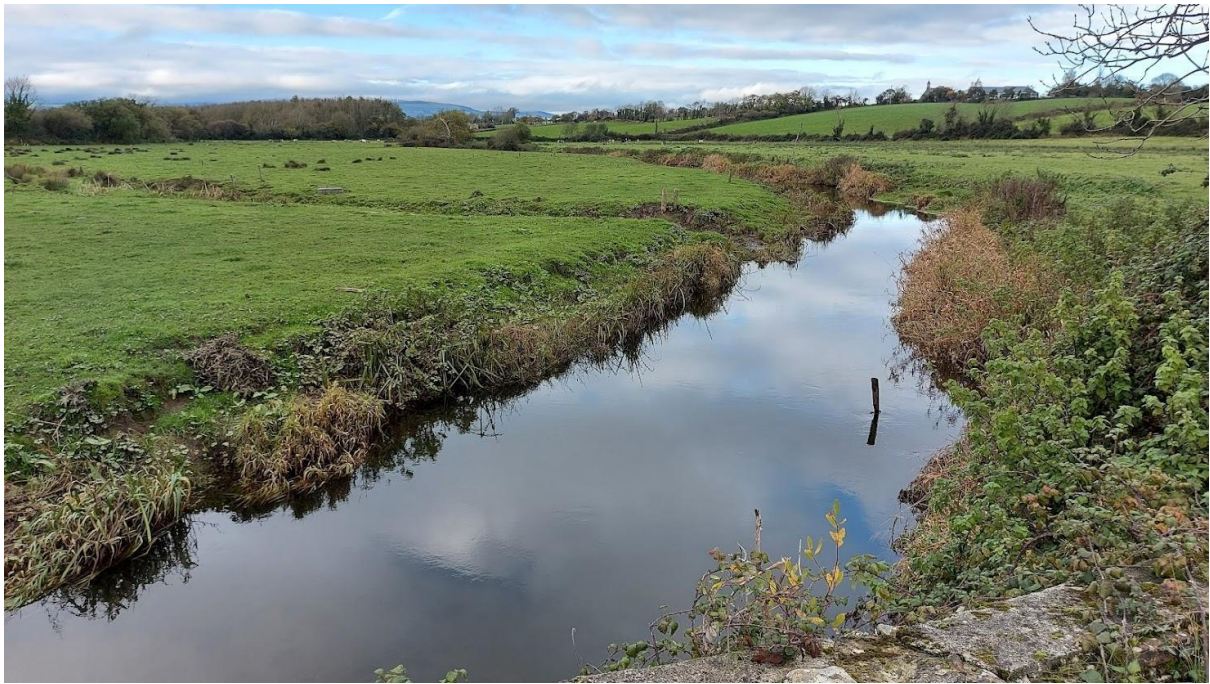
Figure 1: View from Ahare Bridge, looking upstream/ west (Dónal O'Keeffe, 2021)

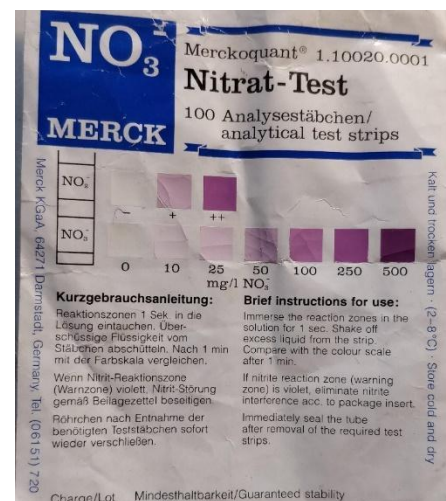
Merckoquant Nitrat-Test strips were used to gauge nitrate concentration within the river. Nitrat-Test enable nitrate concentration to be estimated in a water sample on a scale of 0-500 mg/l. The strip was immersed in a water sample from the river for one second. Excess liquid was removed off the strip and then the colour result compared with the colour scale on the kit after 1 minute. The nitrate concentration was then recorded.

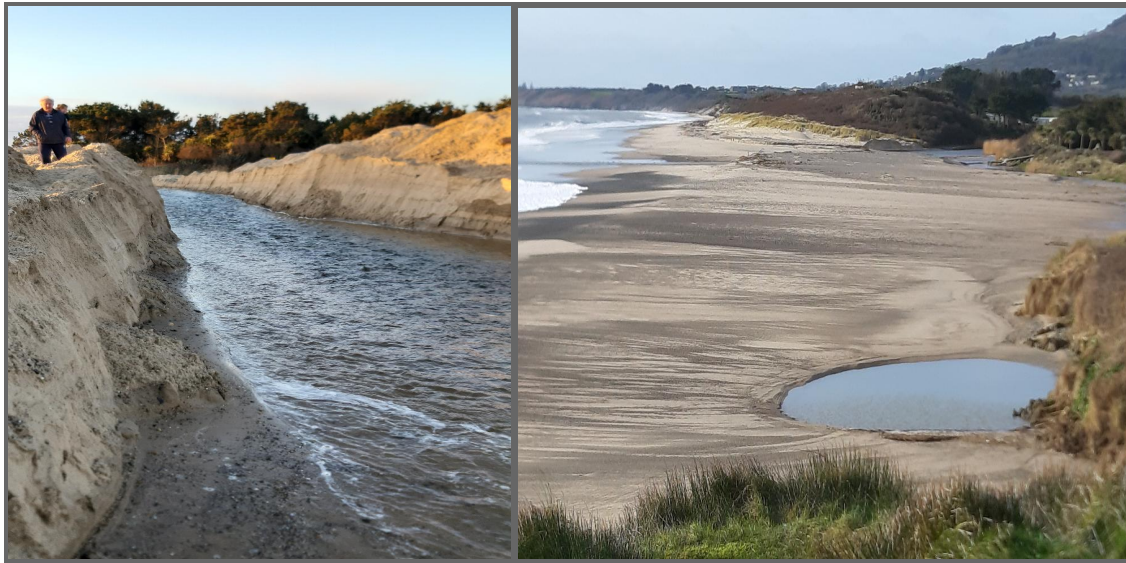
Picture 1 (left) taken 3rd February, showing ~14ft high, unstable sandbanks following the cut out. Picture 2 (right) shows remnant of original estuary in the foreground with the manmade, direct route to sea visible in the background (photos courtesy of Cathy Lee)

A landward flow vs seaward flow was observed at the bridge along with water level. As shown below in Chart 3, on approximately  $\frac{1}{3}$  of days in both April and May the flow was landward. It should be noted that an unauthorised cut out of the river was carried out in February, with the aim of lowering the water level by facilitating flow to the sea, which may have influenced the water levels at this time of year.

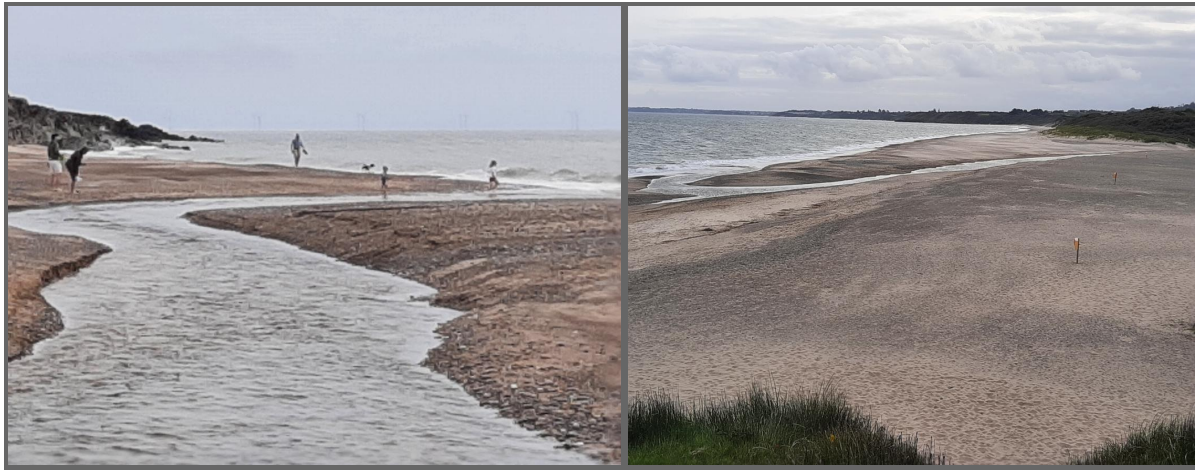
Picture 3 (left) was taken in August 2020, facing north and showing free flowing exit to sea, returning to its original route. Picture 4 (right) was taken on 29th September 2020, showing rivers complete return to its natural flow (photos courtesy of Cathy Lee)

Regarding the unauthorised works, there is no evidence in this study that they had the desired effect of lowering annual water levels in the Ahare. In the accompanying photographs of the Ahare rivers estuary, the complete recovery of the rivers original exit to sea, and related estuarine habitats, took approximately 6 months (noted on 29th September 2020) shown in picture 4. By August 2020 (picture 3), flow appears uninhibited at the beach monitoring site, and has returned to a northerly flow direction. While there was an immediate bounce back to pre cut out water levels, the recovery of the rivers exit along the beach took several months. This is the most notable effect of these works over the duration of the study.
