# **FLOODING ON THE LOWER RIVER INCH, WEXFORD**

Paul Johnston,  
December 2019

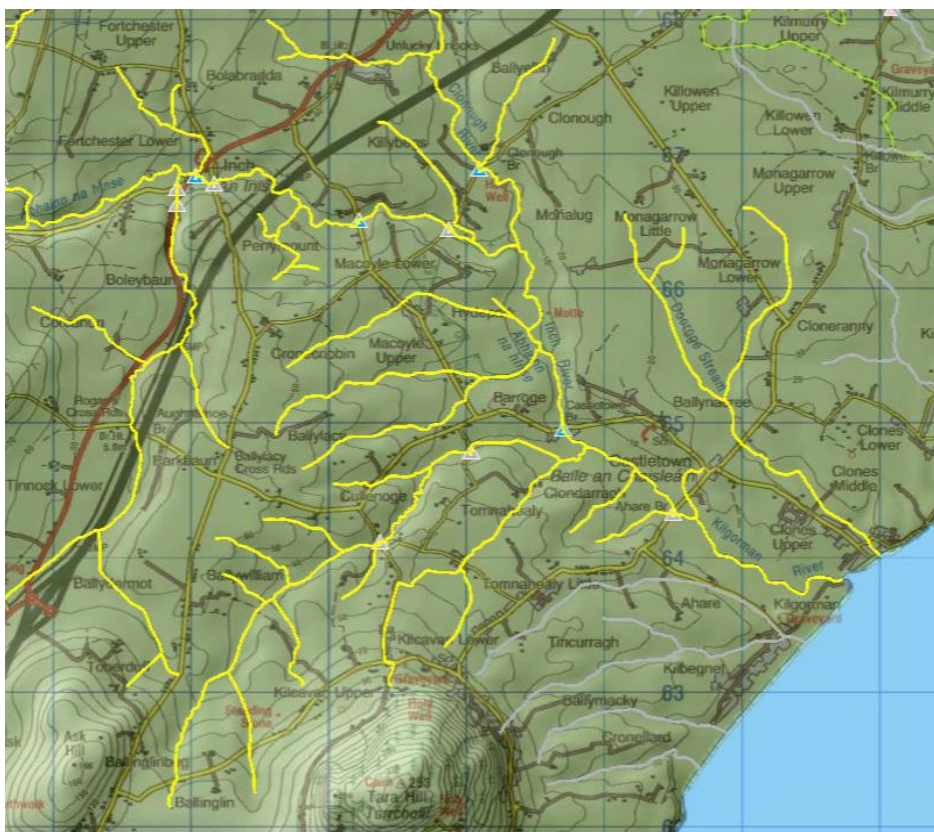
There is considerable concern at the reported increase in the frequency of flooding conditions at the bridge where the embankment and road comes under water, causing dangerous driving conditions. While the frequency of flooding may in part have been affected by an increase in storm rainfall under the influence of climate change, the presence of the low embankment suggests that flooding of the road was not a frequent occurrence historically. In short, the design of the road would have been expected to accommodate occasional flood events on the river as it is known to cross the entire width of the flood plain at that location. However, under current conditions, it appears that the embankment/road is acting as a partial *barrier* to the river flow draining towards the sea. Figure 3 shows the damming effect on the upstream side of the embankment.

Fig.3 Inch River at Ahare Bridge in flooding conditions; road acting as a dam; looking south

Normally, a flood plain is a natural attenuation device for flooding as it acts as storage and causes a reduction in flow velocity. That might also have been the case here but for the current barrier effect of the road. However, it was reported by local residents that there are up to 7 culverts under the embankment but most are silted up or blocked. These would have served to allow most flood waters to pass readily under the road. Thus, it is suggested that opening these and restoring their function in order to fully utilize the flood plain downstream would go a long way to reducing the flooding risk at the road. Moreover, it would help to restore the floodplain as a natural wetland, as a refuge for wildlife with characteristic vegetation and, indeed, as an amenity. Such re-establishment of a floodplain for flood control is increasingly seen internationally as a sustainable 'natural solution' for mitigating flood risk and it is clearly of benefit here, provided it is carefully managed. Raising the road would be an ad hoc solution but would not mitigate the flooding of land upstream of Ahare Bridge.
